Dust Reduction (Sugar)

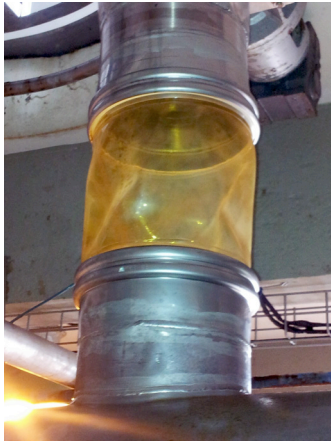
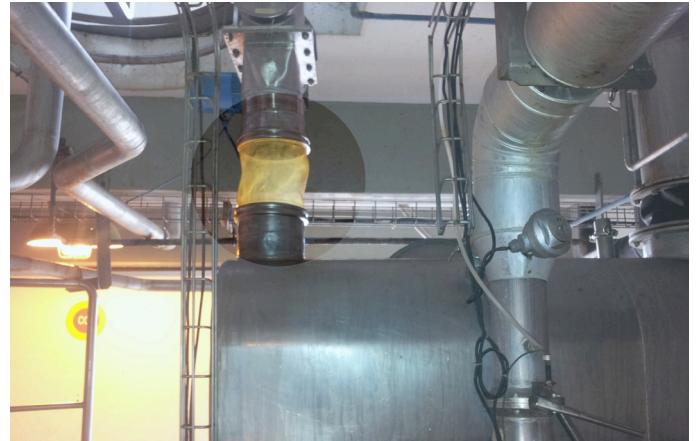
A coned flow-correction ring was installed on the rotary sifter to help reduce abrasion on the connector by directing sugar away from the fitting. A standard length BFM® Seeflex fitting was used with an increased diameter to accommodate for the sifter throw. In addition to the much cleaner, dust free environment, the connector life has been increased from 5 days to 9 months - a substantial saving in downtime and maintenance.
